## **Saab 9\_5** **Vehicles from chassis no.:** **W3087635 to X3005081**

### **Poor contact at ground point G30.**

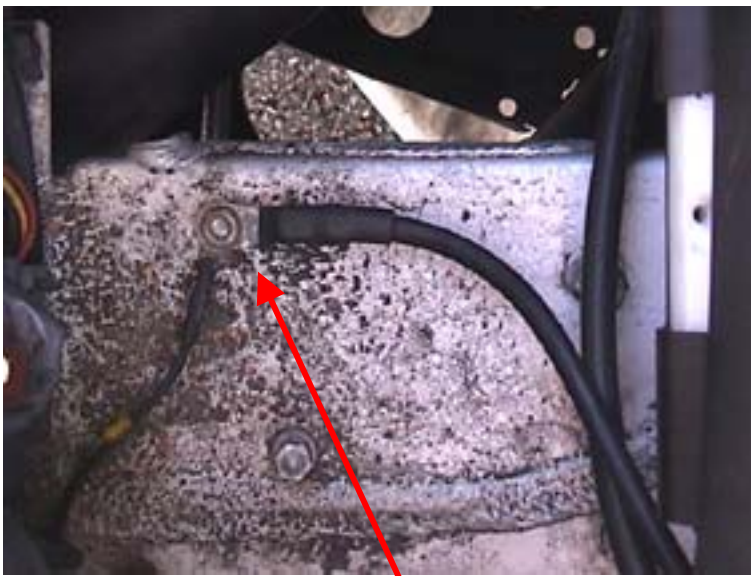
Ground point G 30

If there are complaints with these vehicles that faults occur with the following components/systems: left-hand lighting function, left-hand headlamp wiper, headlamp relay, alarm siren, vacuum pump, pressure sensor, cooling fan motor and relay, washer pump and filling level sensor, one possible cause is a poor contact at the ground point G 30. This ground point is in the engine compartment in front of the left-hand wheel housing.

To eliminate the fault, the ground connection must be checked. If necessary, corrosion must be removed and perfect contact re-established.
