## Issue no. 08/2024

### Suspected leaky fuel filter elements

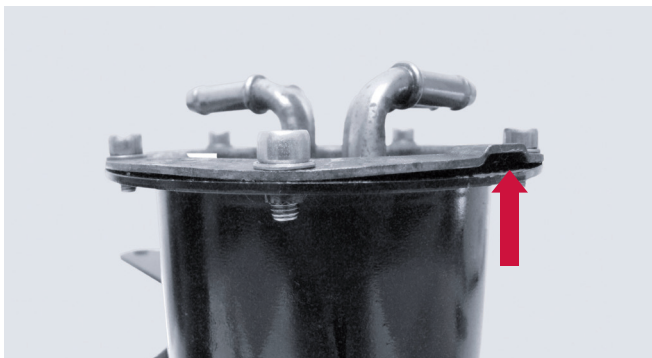
Figure 1: Correct point for levering off the cover

The complaints relate to the filter elements for VW/Audi KX 178 D, KX 228 D, and KX 220 D. Our filter specialists inspected the components in question and did not find any damage to the filter elements or seals. However, they did find significant deformation of the housing covers, which was probably caused by the filter housings being opened and/or closed incorrectly.

- The housing cover and associated sealing ring may only be levered off at the intended point (see Figure 1).
- Suitable tools should be used for disassembly (VAG recommends the special tool VAS 6543).
- The new cover sealing ring must be sufficiently coated with fuel before assembly.
- The housing cover should first be pressed onto the housing by hand to prevent tilting and ensure the seal is seated securely. Only then should the cover be screwed to the housing.

To ensure the filter element is replaced properly, and to prevent damage, the filter housing may only be opened at the intended point using a suitable tool. The cover seal should be coated with fuel before fitting and the cover pressed on by hand before it is screwed into place.
