# Potential tensioner setting problem

Adjusting the timing belt tensioner on some Volkswagen and Audi 1.6/2.0 TDi EA288 engines, from 2012 on, requires a few particular steps that may not be obvious to a mechanic. If the tensioner is not set correctly, catastrophic engine failure may occur. REPPERT Alistair Mason provides information on how to avoid this potential problem.

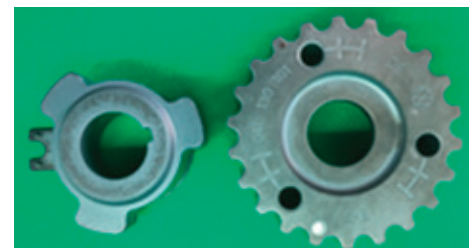
Visually, neither the camshaft or high pressure fuel injection pump sprockets appear to have slotted adjustment holes. However, if you examine them carefully, the camshaft has a small Torx bolt in a small slotted hole, and the fuel pump sprocket is a two-piece unit, the sprocket part rotates back and forth on the inner hub.

The Torx bolt on the camshaft sprocket needs to be slackened when tensioning the belt

Lock the camshaft sprocket with a pin, to counterhold the camshaft sprocket. Slacken the centre bolt 90°, and loosen Torx bolt to allow sprocket to move back and forth in the slotted hole.

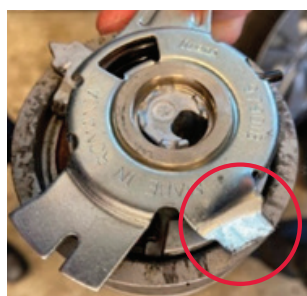
It seems that the camshaft & high pressure fuel pump pulleys are not being slackened during the timing belt replacement process. If not done correctly when tensioning the new belt, the tension is only set on one span of the belt. The other two spans are still slack, as the locked pulleys and shafts will not rotate to allow the slack to be pulled to the tensioner. When the belt beds in, the tensioner rotates to take up the slack until it hits the stop tab. As the vehicle continues to run, the tensioner keeps hitting the stop tab until it breaks, then failure occurs.

If not rectified, this amplitude (or vibration) will eventually destroy the tensioner, often causing catastrophic engine failure.

A tensioner that was damaged by incorrect tensioning

Even though the locking pins will still be in place, the camshaft and fuel pump sprockets must be free to rotate, allowing uniform belt tension across the complete circumference of the belt.
