Troubleshooting guide Lambda Sensors

Lambda sensors play a vital role in reducing exhaust emissions and fuel consumption, as well as optimising engine performance, but how can you tell if they need replacing? Alan Povey, technical expert at DENSO helps you diagnose the most common faults.

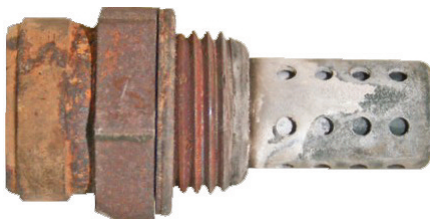
Antifreeze contamination

Excessive grainy white-grey colour, sometimes greenish deposits.

Cause: Contamination due to the presence of coolant fluid in the engine cylinders.

Solution: Check the engine coolant system, especially the head gasket, for leakage and repair if required. Replace the sensor.

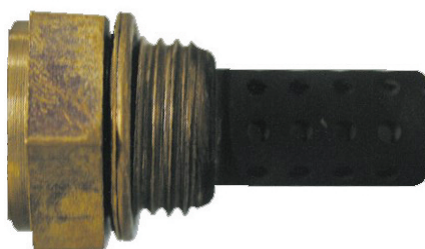
Oil contamination

Excessive dark grey / black deposits.

Cause: Contamination due to excessive oil consumption.

Solution: Check the engine for oil leakage or wear, and repair if required.

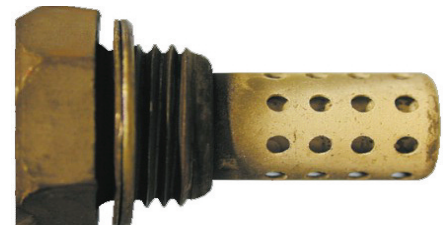
Additive contamination

Excessive red or white deposits.

Cause: Contamination due to use of excessive or harmful additives. Certain ingredients of fuel additives can contaminate the Sensor element. When burned in the engine, they cause fumes that will contaminate and/or clog the sensor element.

Solution: Clean the engine and/or fuel system to remove the additives. Replace the sensor.

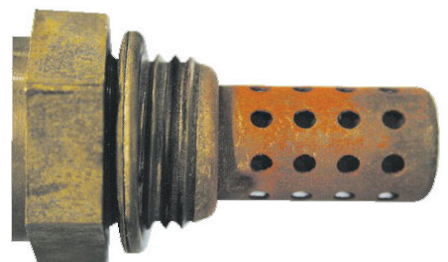
Lead contamination

Shiny, dark grey deposits.

Cause: Contamination due to use of leaded fuel. Lead attacks the platinum which is present both on the sensor element and in the catalyst.

Solution: Remove the leaded fuel from the vehicle, and refill with lead-free fuel. Replace the sensor.
