# BMW 320 - Rear brakes in a bad way

**The brake discs were badly corroded and the pads and shoes needed replacement**

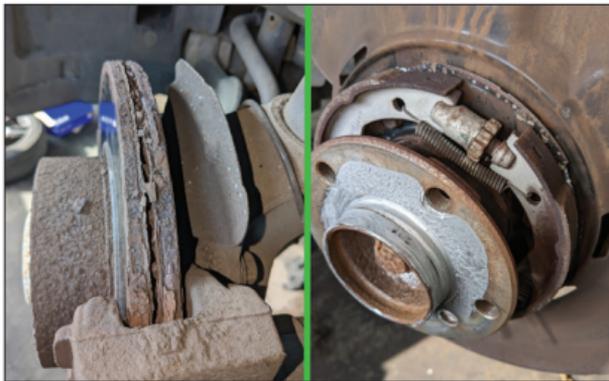
The rear brakes were the source of the low pad warning, and not only were the pads low, but the brake discs were also in a poor condition. New pads, discs and hand brake shoes were needed to get it ready for the test.

Adjusting the shoes before refitting the pads gives the best chance of ensuring the shoes are adjusted correctly. It prevents friction from the pads from distorting the feel of the spinning disc.

Once all back together, the BMW was presented for the test and passed without issue.
