BMW 5 Series - Glow plug puzzler

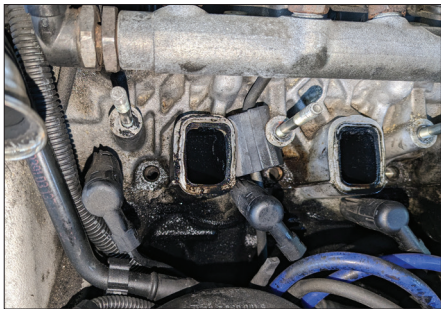
The inside of the caps connecting to the glow plugs were the source of the trouble

Again nothing was showing up as indicating a problem. Only when I looked carefully into the caps that secure onto the glow plug tops, did I discover that while the lead on number two glow plug appeared to be ok, it was not making a good contact.

A little adjustment and cleaning was needed to the cap. After rechecking, all was well. With the inlet manifold back in place and the engine back up and running, I could confirm that the code had cleared and all was well.
