Citroen Berlingo - Non-working window

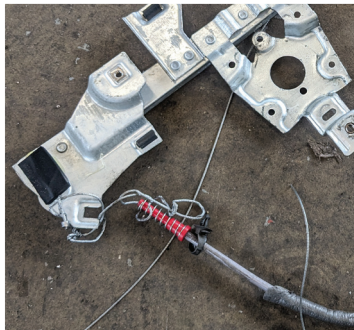
This is exactly what I saw, the cable mechanism of the winder had frayed and then the loose strands had wound around the mechanism escaping from the outer cables causing the window to jam in place.

The old regulator cable was frayed and badly broken

The access to the window regulator is a quick and simple job on this Citroen and gets a book time of under one hour. The regulator is available without the expense of the window motor, so the whole job can be completed at a reasonable cost.

Once the new regulator was in place, and the motor refitted, the window channels were given a good spray of silicone lubricant, to ensure that the window would glide up
