Jaguar E-PACE EPB failure

This 2017 Jaguar E-PACE was booked in for a failure of the electric parking brake system (EPB). The system was scanned for diagnostic trouble codes, in the parking brake system, which is combined with the ABS control module. Each motor has 2 wires passing through 2 connectors, before arriving at the control module.

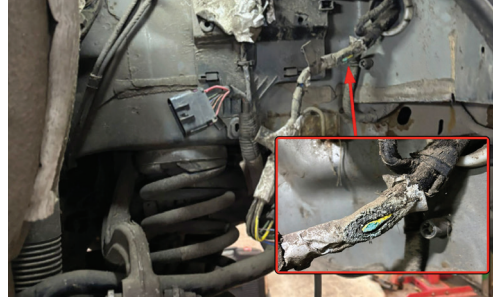
Wiring to the EPB Motor was damaged, at arrow

Tracing back the wiring, and removing the rear wheel inner liner, we discovered the wiring loom had been rubbing on the chassis. The insulation was worn through, and the wire had begun to corrode.

The damaged loom section was repaired, the fault code was cleared, and the system returned to normal operation.
