Nissan S Cargo - Exhaust gas blow out

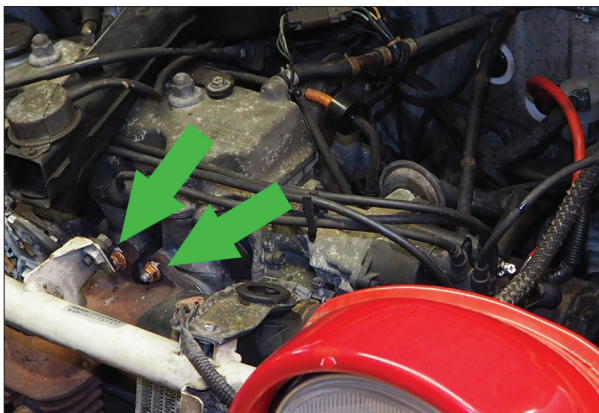
Having a look, I could see a gap between the exhaust manifold and engine was allowing the gasses to escape. My biggest concern was the rusty condition of the manifold studs. I knew that this was going to be the trickiest part of the job.

Fitting new nuts and studs when reassembling should hopefully ensure that the next time the manifold needs to be removed, the job will go smoothly

Fortunately, there was quite a decent amount of access at the front of these vehicles, so at least this was one problem I didn't have to contend with. I started by soaking the nuts and studs with penetrating fluid before starting the job. I was quite pleased when a few of the studs came out with the corroded nuts.
