## **Citroen C5 estate** **Model year up to 18 February 2002**

### **Engine will not start**

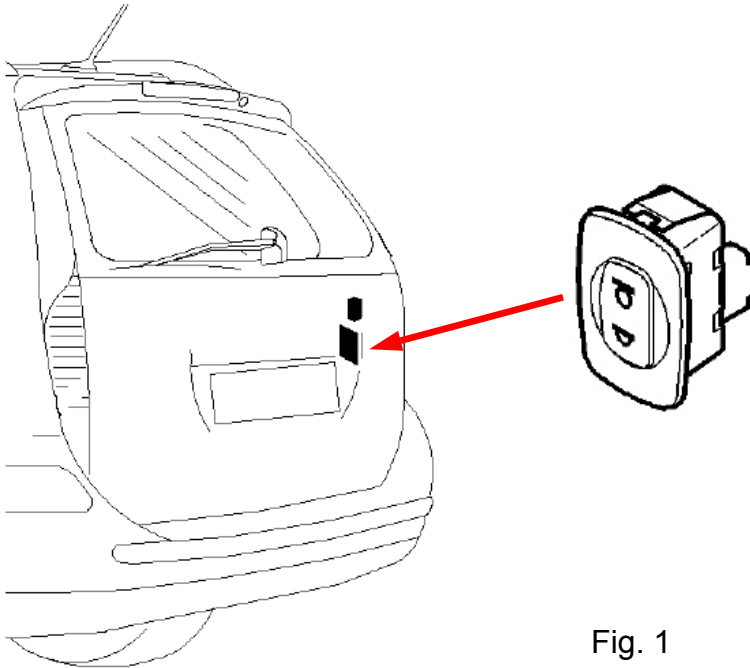
Fig. 1

If there are complaints about the above-mentioned fault, the cause could be a flat battery. This condition arises increasingly if the vehicle has been at a standstill for a longer period of time. The battery is discharged due to excessive quiescent current. The increased quiescent current may arise due to a permanently illuminating LED. This LED is located in the suspension-height switch, which is located in the rear right-hand area of the boot. The power consumption due to permanent supply of the LED is 20 mA. In this case, the earth cable of the LED must be cut. As the cover of the switch is non-transparent, illumination is superfluous.

- Remove the switch for the suspension height (on the right, in the boot, see Fig. 1). When removing the switch, care and patience are required due to the fastening.
- Remove the plug from the switch.
- Press down the locking tab of the earth cable 7749 (see Fig. 2) and pull the socket contact out of the plug housing.
- Cut off and insulate the earth cable where the wiring harness exits.
- Refit all removed parts in reverse order.
