BULLETIN

Lexus IS250/IS350 Model year: 2006 - 2007

Condensation in interior

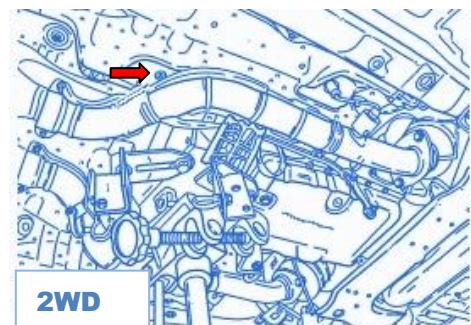
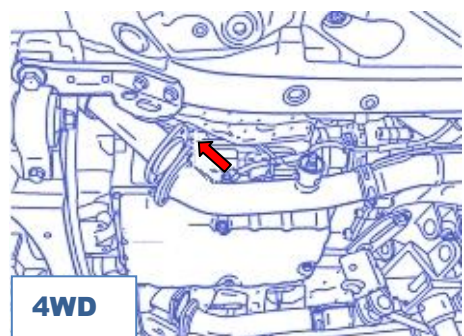
On the above vehicles, a blocked condensation drain in the air-conditioning system can lead to an ingress of water in the vehicle interior.

You can see the condensation drain if you stand on the transmission side and look at the vehicle undercarriage, above the transmission (see drawings).

You can now clean the grommet for the condensation drain using a long, blunt object or replace it with a modified version. For more information, please contact your authorized dealer.
