Mercedes Benz C-Class (W203) All models with engine 111 and 112

Ticking noises on the interior.

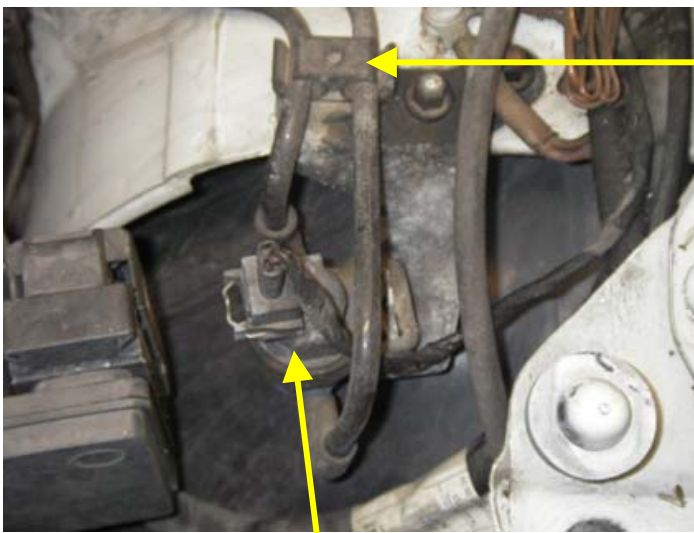
If there are complaints with these vehicles that ticking noises can be heard on the interior, one possible cause is the timed valve of the evaporative emission control system. The noises are transferred to the bodywork via the valve brackets the lines are clipped into. To eliminate the fault the attachment clips for the lines have to be replaced.

Attachment clips

Timed valve

The replacement clips required can be purchased from the local authorised dealer.

The modified clips have been being installed in the factory since model year July 2001.
