## **Mercedes C-Class (203)**

### **Windscreen becomes fogged**

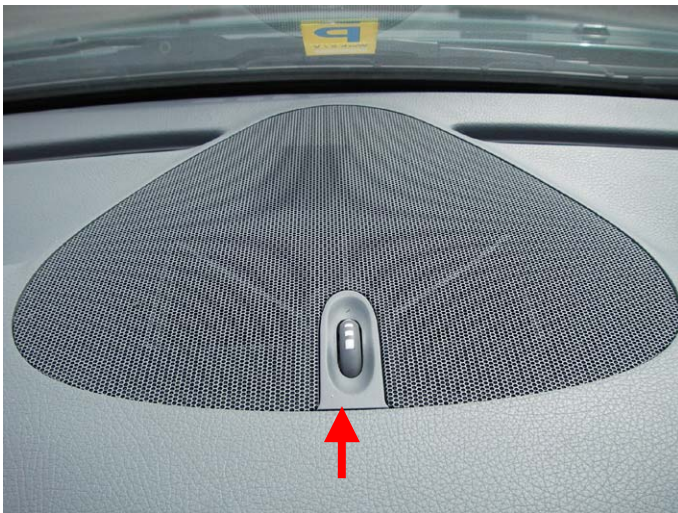
In some of the above-mentioned vehicles it may be that under certain operating conditions, the windscreen becomes fogged. Here, it is not the entire screen that becomes fogged, but rather just a triangular area in the lower-middle section of the screen.

In order to resolve the problem, the air distribution grille for the central air vent (above the dashboard) should be replaced with a modified air grille. This can be obtained from the vehicle manufacturer. Vehicles affected are those with vehicle identification numbers: xxx xA to 237174 and xxx xF to 183960. The air distribution grille can be removed easily by unclipping it (see photo) and removing it upwards.
