## Mercedes Benz M-Class

### Faulty function, central air vent and fault code B1202

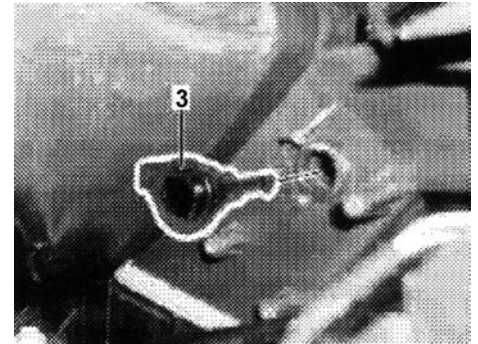
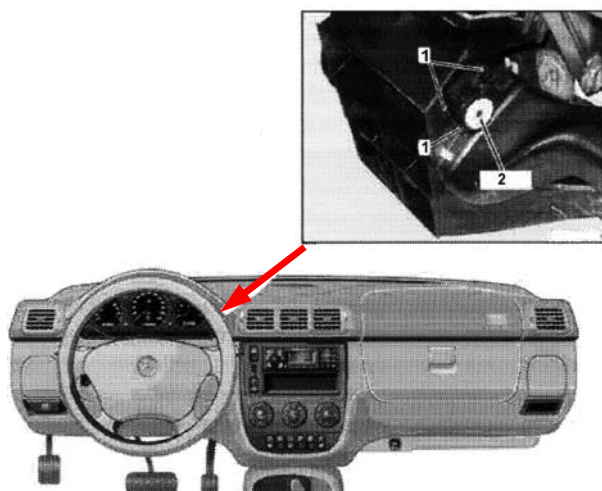
If there are complaints about the above-mentioned problem, the reason could be a faulty setting motor sleeve. With this vehicle, the stop from the setting motor sleeve (central air vent in the dashboard) occasionally breaks off. In this case a new sleeve has to be installed.

- Remove the instrument cluster.
- Loosen the screws (1).
- Remove the setting motor of the central vent (2) on the air channel.
- Remove the sleeve(3) from the air channel and insert a new sleeve.
- Replace the setting motor.
- Reset the setting motor to the zero position with the aid of a diagnosis tester.
- Replace the components in reverse order.
- Delete the fault store.
- Check the system for correct function.
