## **Mercedes W210 (E-Class)**

### **Replacement starter is not functioning**

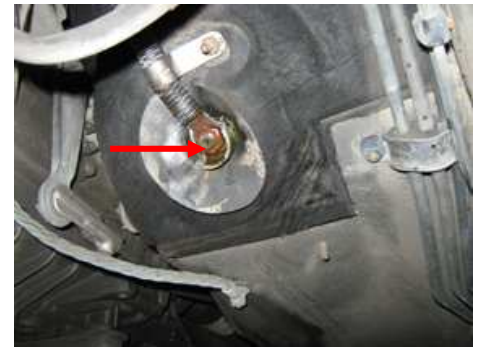
Figure 1

When removing the starter, it is sometimes necessary to disconnect and then reconnect the positive battery cable connector on the undercarriage of the vehicle (Figure 1). At that time, the other side of the connection (in the vehicle interior, Figure 2) may come loose, which causes an interruption in the power supply. Consequently, the vehicle will not start and it will seem as though the starter is not functioning.

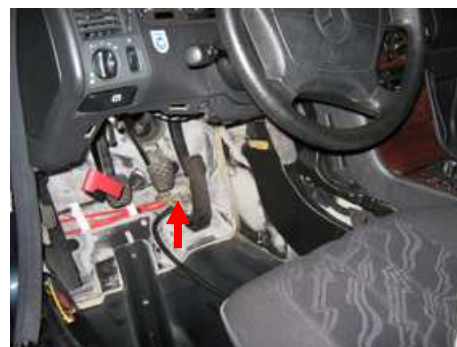
Figure 3

To solve this problem, check the cable connections in the footwell on the driver's side (in left-hand drive vehicles) and reattach if necessary. To access the footwell, remove the panels and loosen the accelerator pedal (Figure 3).
