## **Opel**

***Astra F, with air conditioning system***

***Omega B, with air conditioning system***

### **Interior blower without function**

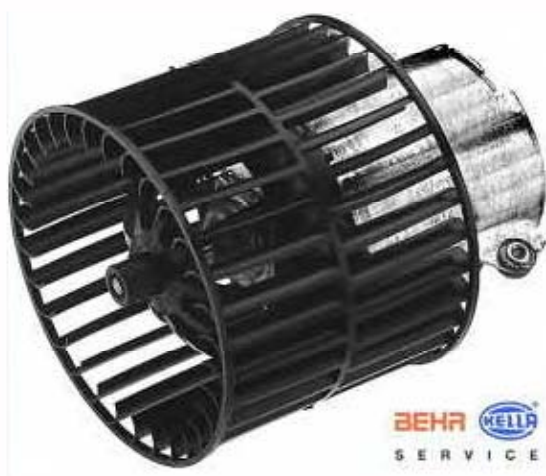
If the interior blower motor in the above-mentioned vehicles should fail or reveal malfunction, this can be connected with operation of the air conditioning system. Operating the air conditioning system can lead to the collector of the blower motor icing up. This leads to malfunctions and/or to complete motor failure. In cases of complaint the blower motor should be replaced. Blower motors can also be found in the *Behr Hella Service* range (photo shows the motor for the Astra F).
