Opel

Astra G / Astra H

Model year: 1998 - 2009

Recirculated air flap is not working

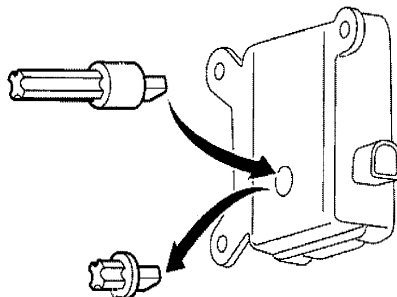
With the above-mentioned vehicles, a damaged shaft can lead to a malfunction of the recirculated air flap.

To remedy the situation, a modified recirculated air flap housing has to be installed. To do this, remove the short shaft in the recirculation flap motor and mount the long shaft included with the modified housing (see drawing). After conversion, a basic setting or functional test should be carried out.
