Opel

Astra G Model year 2003–2004
Zafira Model year 2003–2004
Vectra C Model year 2002–2004
Signum Model year 2002–2004
With engines Y20DTH / Y22DTR

Malfunction of the EGR valve

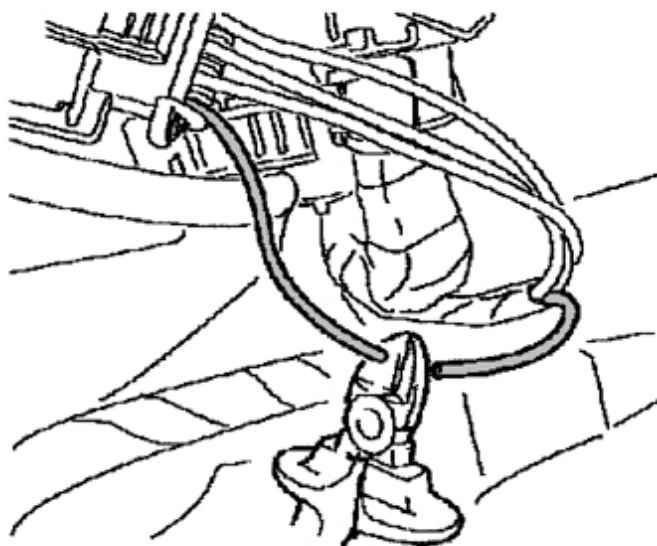
Fig. 1

If there are complaints about the above-mentioned fault, the cause could be faulty contacting. Also, fault code P 0400 (C) and/or fault code P 0400 (9) are/is stored. In addition, the vehicle goes into "limp-home" mode.

- Cut through the cable (0.5 / grey-black) which leads from slot 4 on the electric EGR valve to connection 19 on the pump valve. Cut through the cable approx. 20 mm behind the plug of the EGR valve (see Fig. 1). In relation to this, on no account may the pump plug be loosened.
- After this, insulate the cable ends in a watertight manner and fasten to the cable loom using insulating tape (see Fig. 2).
