## **Opel Omega B Model year: 1996 With automatic air conditioner**

### **Front window fogs up**

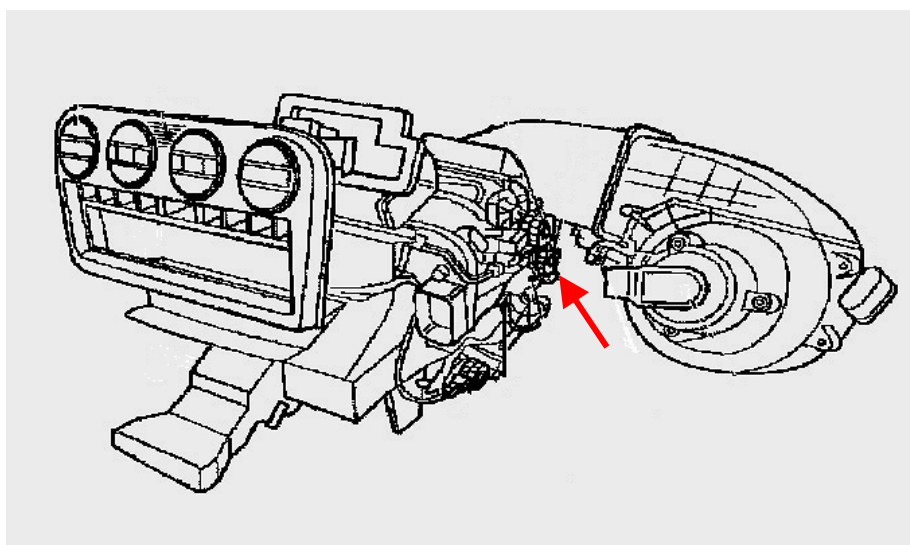
If the windscreen fogs up on the above-mentioned vehicles after the engine has been started and the air conditioner is switched on, this can be connected to the actuator motor of the defroster flap (see drawing). If this flap does not close properly, the result can be fogging of the windscreen. A diagnosis tester can be used to attempt to remedy the situation by basic setting of the actuator motors. If necessary, the actuator motor must be replaced. From vehicle identification no. 1024050 onwards modified actuator motors were installed in the factory.
