## **Opel Vectra B**

**Model year: 1996 - 2001**

**Engine: X16SZR, X16XEL, X18XE1,  
Z16XE,**

### **Poor air conditioner performance, loss of refrigerant**

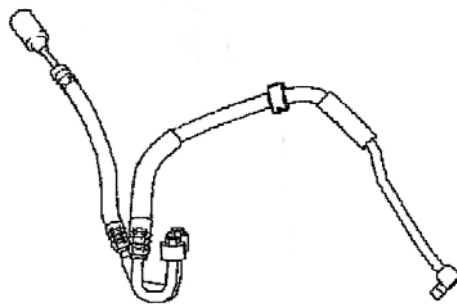
If the cooling performance of the air conditioner deteriorates or a loss of refrigerant is established, the refrigerant lines leading to the compressor should be checked. In this area, vibration-related cracks could lead to leaks. In this case, both lines must be completely renewed. To do this proceed as follows:

- Extract the residual refrigerant from the air conditioner
- Remove the top two brackets of the coolant radiator
- Unhook the relay carrier on the battery
- Remove the sound-proofing mat at the side
- Renew the refrigerant lines (see drawing) including rubber dampers and attachment clips. When routing the lines make sure these do not come into contact with other components (bodywork etc.).
