## **Opel Vectra C estate Model year from 2004 to 28/02/2005 All vehicles with electric tailgate**

### **Faulty tailgate/Tailgate does not close**

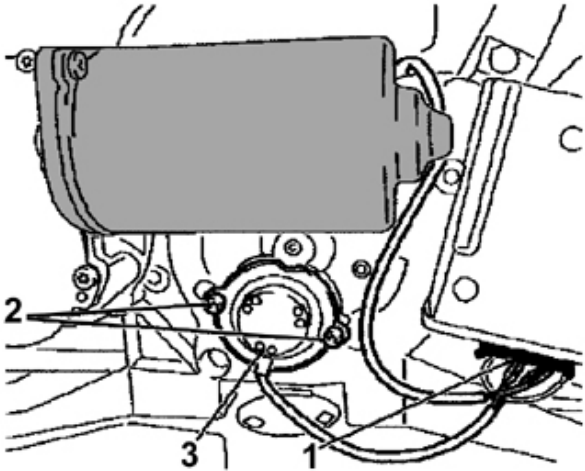
Fig. 1

If there are complaints about the above-mentioned fault, the cause could be a defective potentiometer. This potentiometer is responsible for the closing process. After activation, the tailgate stops after approx. 2/3 of the closing process. In this case, proceed as follows:

- Disconnect the battery.
- Remove the boot panelling.
- Remove the potentiometer. To do this, remove cable plug F9 □ 34 (see Fig. 1, Item 1). After this, remove the screws (see Fig.1, Item 2) and remove the potentiometer (see Fig.1, Item 3).
- Open the locking on the plug. (see Fig. 2). **Caution!** The cable colours and the slots of the PINs should be noted.
- Unlock the stated 3 PINs (see Fig. 3) using a suitable tool and remove from the plug.
- Plug the PINs of the new potentiometer into the plug again. The PINs must lock into place audibly.
- After this, reassemble the plug.
- Install the potentiometer and reconnect the plug.
- Connect the battery.
- After this, manually close and open the tailgate five times.
- After this, let the tailgate close twice automatically.
- If operation is correct, reassemble all removed parts in
