# BULLETIN

## Opel Zafira B Model year: 2005 - 2009 With air conditioning

### Recirculation air flap malfunction

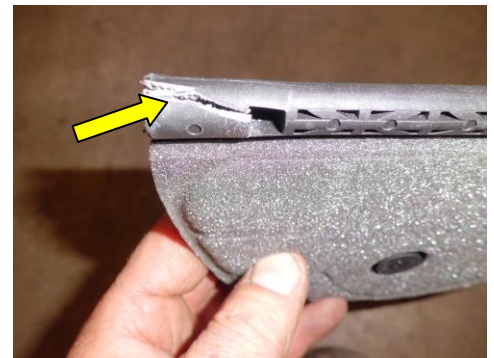
Figure 1

In the above vehicles, a damaged drive (Figure 1) between the recirculation air flap shaft and the recirculation air flap itself can lead to a malfunction.
