Issue no. 10/2024

Engine damage due to incorrectly mounted valve springs

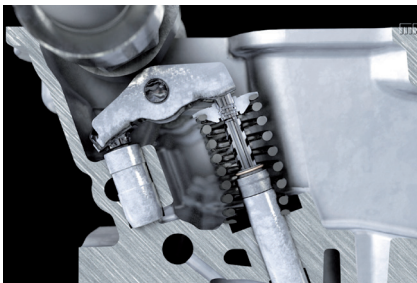
If a valve spring is mounted at an angle when the valves are installed, it will be subjected to a greater load on one side, even when the valve is closed. When the valve opens, the spring is compressed to the limit. The stroke of the camshaft creates a

very large lateral bending moment in the upper area of the valve shaft. Due to the recurring bending load, the valve tears off, falls into the combustion chamber, and is severely deformed by the piston and cylinder head.

Figure 1: Valve spring mounted at an angle

When mounting the valve springs, ensure that they are seated correctly in the cylinder head. Used valve springs should be checked for dimensional accuracy before reinstallation. We recommend that you always use new valve collets when installing new or used valves.

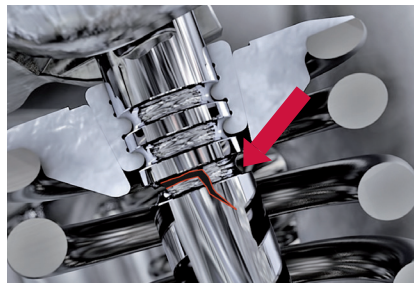
- The damage occurs immediately after the repair.
- The valve fracture starts at the third groove (the lowest in the installation position) and runs across the valve shaft (see Figure 2).
- The valve collets are partially deformed at the partitions.
- There are uneven pressure marks on the contact surfaces of the valve spring in the cylinder head (see Figure 3).
- The fracture surface exhibits the typical structure of a forced rupture.

Figure 2: Valve fracture at the lowest groove and across the shaft

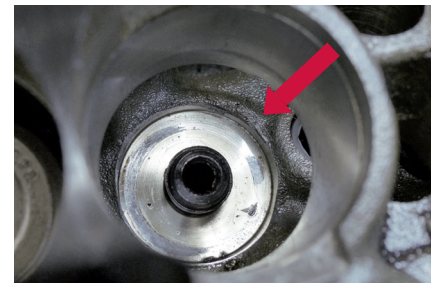
Figure 3: Pressure marks on the cylinder head
