Land Rover Discovery III, IV (L319)  
and Range Rover Sport (L320)

## Compressor for Air Suspension

**Problem**

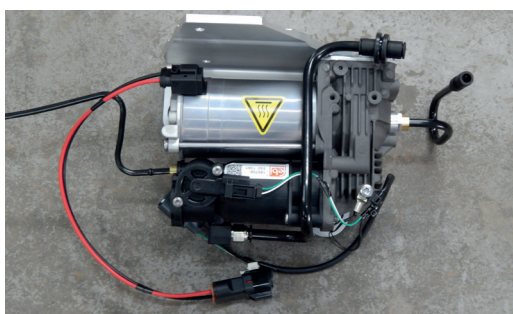
Figure 1

During the production period of the models listed above the vehicle manufacturer changed the design of the air suspension compressor to improve reliability. Therefore, febi have created a kit which follows O.E. that can be installed on all the models listed above, with parts included to adapt the earlier models. (Fig.1)

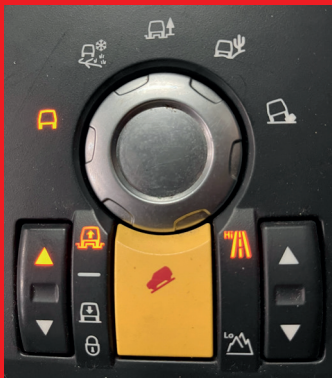
Figure 2

- Ensure all doors are closed
- Start engine and allow to idle with the transmission in the park (P) position
- Press and release suspension control button (Fig.2)
- A warning symbol illuminates to indicate suspension is being raised
- A warning symbol illuminates to indicate suspension system is in maximum ride height mode
- Parking brake should be applied and switch the ignition off

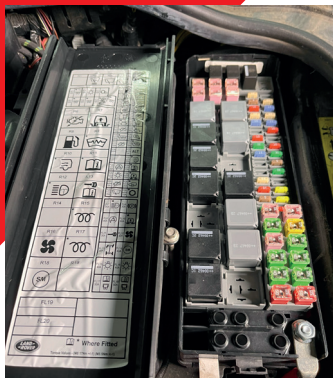
Figure 3

Open the bonnet, lift the fuse box cover, remove relay R7 and raise the vehicle. (Fig.3)

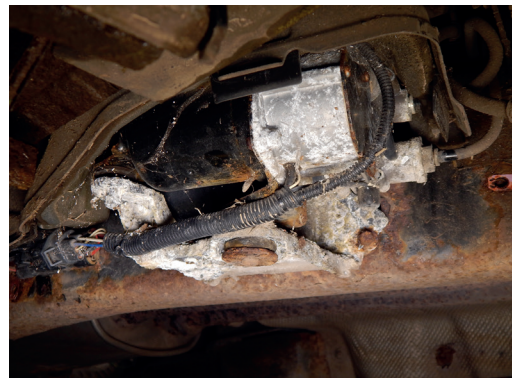
Figure 4

If the vehicle has a Hitachi or early AMK compressor, (Fig.4) the pneumatic air lines need adapting and a software update which reduces the run time of the compressor must be carried out, as well as a firmware update on the control unit. Failure to do these will void the warranty and may also severely damage the compressor.

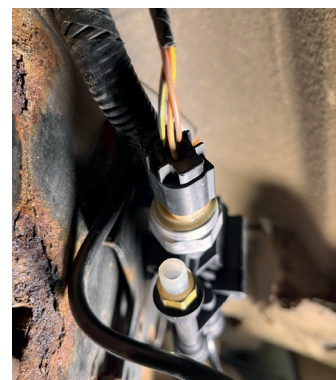
Figure 5

Disconnect the three pneumatic air lines and the two electrical connectors, undo the three chassis fixing bolts for the compressor bracket and remove the compressor and upper insulation cover. Remove the air line to the solenoid valve and install the quick connector supplied with the kit. (Fig.5) Tighten to 2 Nm. Remove blanking plug and insert the new pipe.

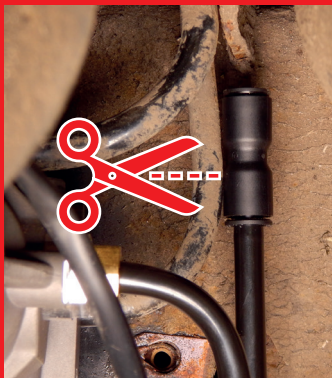
Figure 6

Alternatively, test fit the new compressor assembly to the chassis and align the new pipe with the pipe to be cut (Fig.6) and cut to length using a suitable pipe cutting tool. With the pipe cut to length, insert the brass ferrule into the pipe. (Fig.7)

The two air lines at the rear of the compressor must be adapted. After removing the quick air fittings, the length of the air line pipe must be reduced by 40 mm if a Hitachi compressor is fitted or by 60 mm for an earlier AMK compressor.

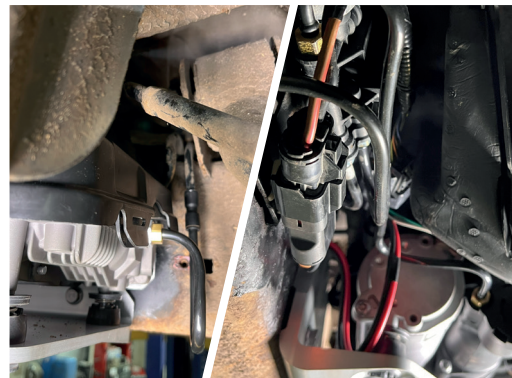
Figure 8

Before installing the new lower cover, check all pipes and cables are routed correctly and will not chafe or cause vibration. (Fig.8)

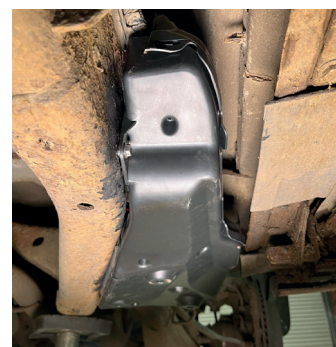
Figure 9

Install new lower cover, refit the wheel and and lower the vehicle. (Fig.9)

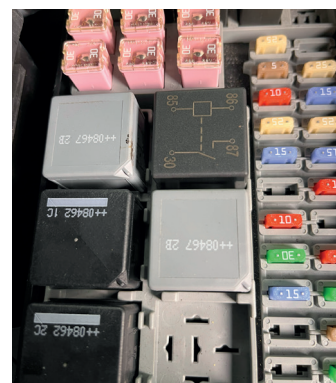
Figure 10

Install new updated relay into position R7 and refit fuse box covers. (Fig.10)
