To fit: Ford B-Max 2012-17, Ecosport 2012-,
Fiesta IV 2008-17, KA+ 16-

Coolant Expansion Tank

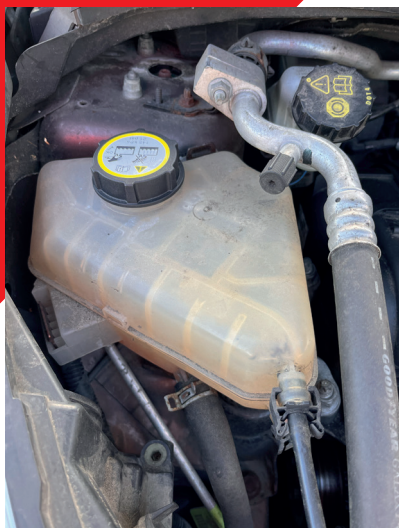
Figure 1

Check the condition of the coolant expansion tank. If it has discoloured (Fig.1) then the plastic has become brittle with age and could be at risk of cracking and leaking. If found in this condition during routine maintenance replacement is advised before any coolant loss issues occur.

To fit a new coolant expansion tank it may be necessary, depending on the model, to remove the headlamp for ease of access. Unclip all hoses and pipes, drain the excess coolant, then free the expansion tank from the metal tags securing it to the inner wing.

Replace with new febi Expansion Tank 188342 and Cap 105933, clip into place, and refit all hoses and pipes. Top up the cooling system with fresh coolant mixture (Fig.2) and refit the headlamp as required.
