**To Fit:**  
Various Citroën, Fiat, Ford, Lancia, Landrover, Mitsubishi, and Peugeot models

## Part Description: Magnet Wheel for Crankshaft

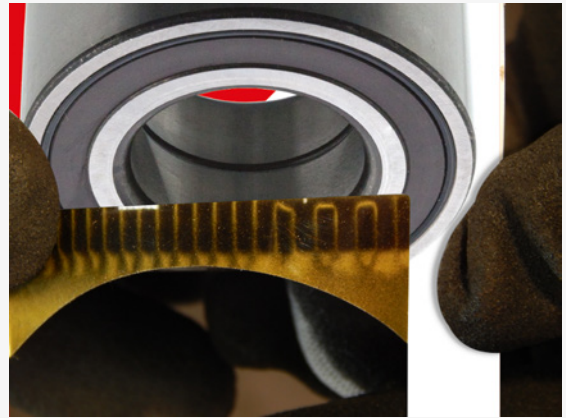
Example of a faulty reluctor using a magnetic test card

A magnetic reluctor is extremely sensitive to any cleaning or handling. As a result, it may become faulty which can lead to an incorrect crankshaft sensor speed signal. This can result in an engine management malfunction with a fault being logged, such as fault code P0336. (An example of a faulty reluctor with damaged magnetic segments is found above). febi recommends replacing the crankshaft magnetic reluctor wheel at the same time as the routine replacement of the timing belt and/or the torsion vibration damper (TVD) pulley.

febi offers this part singularly or as part of a kit to include the TVD and bolt (36433 or 106476). This combination kit enables a professional repair and avoids potential complaints. This saves time and money for both workshop and customer!
