BMW 325 - Failed Heater Blower

MINI Cooper S - Notchy Steering

Scenic - Failed Clutch Due to DMF

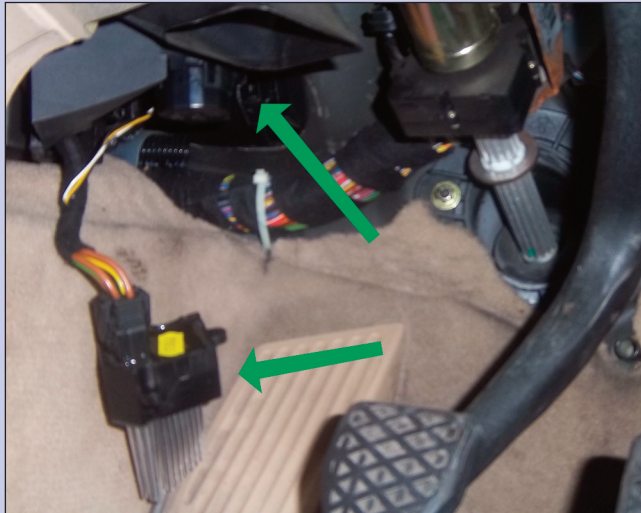
The electronic unit is covered in spiky fins to allow the components to stay cooler, and this outward appearance gives it the nick name of "Hedgehog".

The hedgehog is fitted up under the driver's footwell with limited, but not impossible access

On this 325, the unit is tucked up under the drivers footwell. Access is tight, but not impossible. After confirming that the rheostat was at fault, by plugging the new unit into position, we then set about the fiddly task of actually fitting the unit into its proper place.

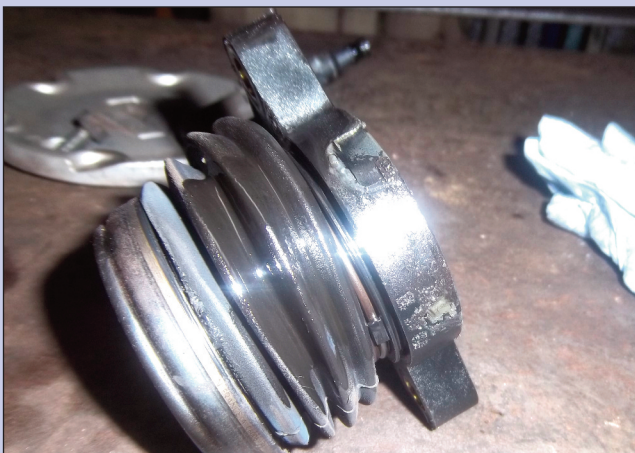
DMF had collapsed and had allowed the slave cylinder to be pushed out further than it was designed to do. The extra travel had allowed the fluid to leak and would have soon caused the clutch to fail completely.

The collapsed DMF allowed the concentric slave cylinder to extend past its intended travel, until it started to leak

A new Dual Mass Flywheel and complete clutch (including the concentric slave cylinder) was fitted. When all was put back together, the customer was pleased that the clutch felt much lighter than it had in years.
