# Ford Focus - Internal EGR Failure

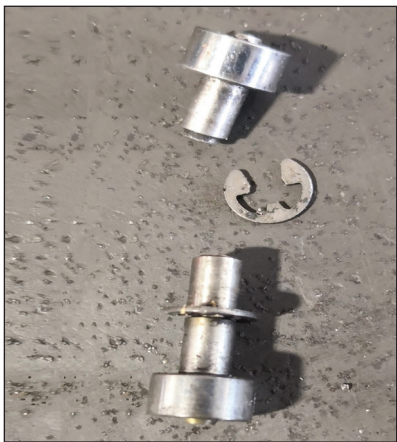
**The pin between the motor and the valve had broken**

When I removed the EGR valve, I found that the pin had broken between the operating valve and the drive motor. As this part is not separately available, a complete valve was needed. At least this allowed the confidence when fitting back together that the problem was going to be rectified.
