# Škoda Kodiaq - Haldex mesh filter

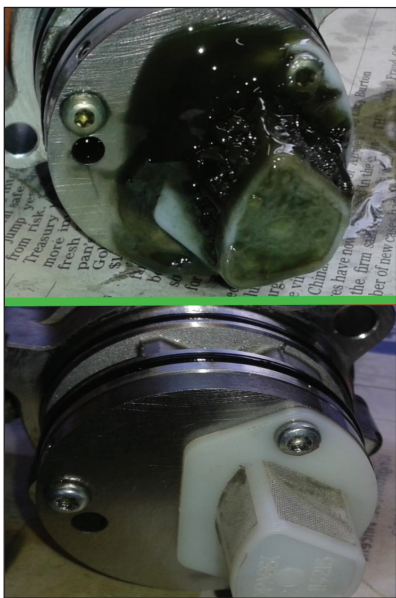
**The filter was quite clogged after only 20,000 miles (top is as found and bottom after cleaning)**

The mesh filter on the end of the pump collects all the contaminated particles of oil. Looking at the condition of this one after only 20,000 miles, I would strongly recommend that this is regularly carried out to prevent undue problems from occurring.

I will admit to being surprised at the condition of the mesh filter after such a short time, especially as mentioned that the oil did look to be very clean. So, if you get a VAG 4X4 in your workshop for a service, it is worth advising the customer to have that Haldex serviced. It could save a few problems in the future.

The Škoda had only covered 20,000 miles, so I wasn't expecting the fluid to be too dirty. The fluid is easily drained down and when draining it looked to be clean. As this unit does not have an external filter, it is a good idea to get the pump fitting kit, which consists of two 6mm bolts and the two 'O' rings and then remove the pump.
