Cam tensioner **pulley fracture** problem

The adjustment cam on the tensioner pulley can fracture during the tensioning process. Continental has provided these instructions for timing belt kits CT1168K1/ K2/ WP1/ WP2/ WP7/ WP9/ K6PRO/ WP8PRO that are for VW, Audi, Seat, Skoda EA288 1.4–2.0 TDi common rail engines.

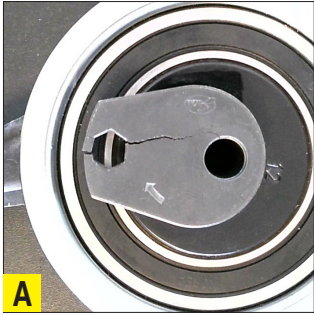
The cause of this fracture is that the fastening nut is over tightened during assembly. As a result, the nut turns together with the eccentric cam during tensioning, subjecting it to an even greater load. This produces too much resistance, causing the adjustment cam to crack (**Fig. A**).

The solution is to only tighten the nut by hand prior to tensioning. Use an appropriate tool to hold the nut securely (**Fig. B & C**) so

that it doesn't turn together with the cam. You now tighten the tensioner pulley by turning it clockwise until the pointer aligns with the marker notch (**Fig. C**). You can then finish tightening the nut
