Burst brake lines during Mercedes W204 NCT testing

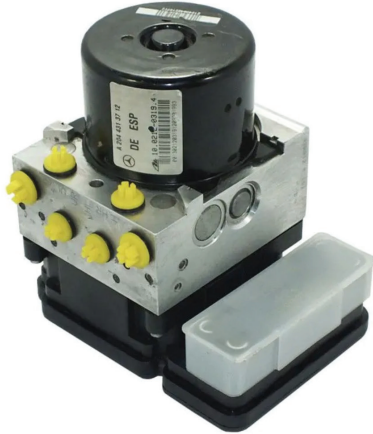
A fault within the ABS modulator can prevent the rear brake circuit from being bled

The Helpline is aware of this known fault , and that it is common with the W204 vehicle series. The failure to bleed is due to a faulty ABS hydraulic modulator. The ABS hydraulic modulator can be sent to a specialist for repair, or it can be replaced, without having to replace the brake control module.
