Peugeot Partner sluggish & losing power

**Keith Shanahan,
Shanahan's Auto Service**

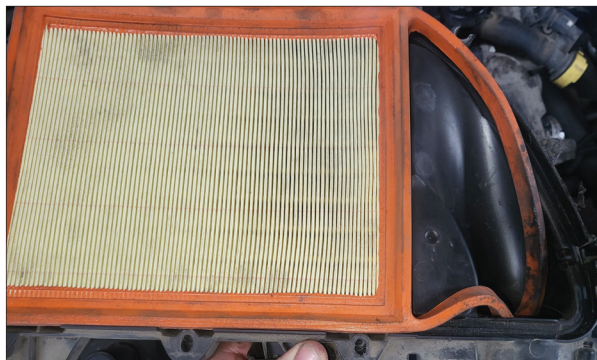
A visual inspection of air filter clearly showed the problem

During my initial visual inspection, I could see the mass air flow sensor had been changed. Further inspection revealed a glaringly obvious problem had been overlooked, the air filter. The air filter had indeed been changed during the service, however it was fitted incorrectly. Under acceleration, the foam seal of the air filter blocked the air flow over the actual sensor, making it read incorrectly. The false reading caused the lack of power, and set the fault code. I simply fitted the air filter correctly, cleared the code and confirmed with a road test it was OK.

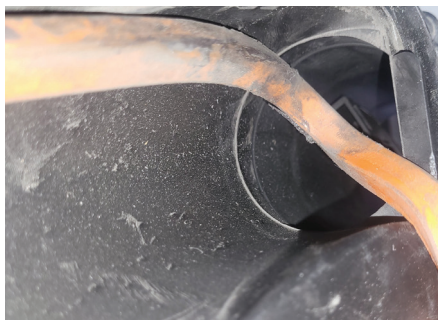
The loose portion of the air filter was interfering with the mass flow sensor
