Subaru Impreza WRX - Steering shake

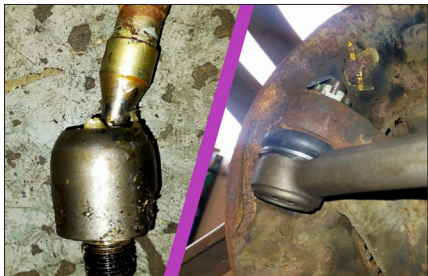
Both the inner and outer track rod joints were worn

complaining of. Play in the steering could be felt, along with a clonk as the steering moved from side to side. Checking the play at the wheels I found quite a bit of movement at the track rod ends and at first thought this was the problem.

I didn't jump to conclusions when I found the wear in the track rod ends, and continued to check out the rest of the steering. This proved to be a good move, as further checks revealed that the inner track rod joints were also worn.

The difference to the steering after the joints were replaced and the tracking re-set was quite dramatic, and the owner was impressed with the improvement of the steering. I would image the tyres will also wear at a less dramatic rate now.
