NEW PRODUCT HIGHLIGHT | JUL2024

Blue Print ADBP960078

Tensioner Assembly for Auxiliary Drive Belt

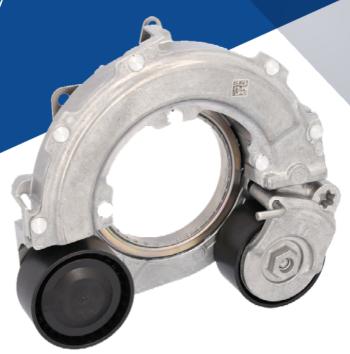
Attached to the starter-generator, this tensioner assembly is an integral component of the ISG (idle, stop, and go) system on the vehicles listed. The ISG system is designed to lower emissions and improve fuel economy by switching the engine off when the vehicle is deaccelerating and then use that energy to both charge the battery and promote faster and smoother engine starting.

The belt required for a starter-generator is constantly exposed to a high level of stress due to the frequent load direction changes and tractive forces that occur when switching from driving the belt (when starting the engine) to generating electricity to maintain the load on the electrical system. This double tensioner applies the correct tension to the belt when operating in all conditions.

Over time the springs start to lose their tension, and due to the high levels of torque these components are constantly put under this can lead to a serious failure of both the belt and the tensioner. The symptoms of a failing tensioner include a squealing/screeching noise from the engine, the illumination of the engine warning lamp, and poor engine performance.

In some cases, the failing of the tensioner on the vehicles listed above has resulted in the crankshaft pulley being damaged, causing significant harm to the engine.
