Audi A2 1.4 TDI

Replacing the light source

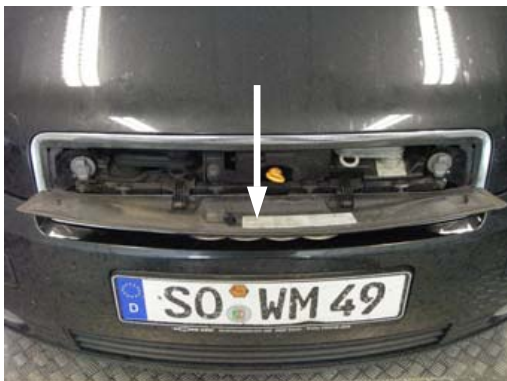
Fig. 1

- Unlock the service flap from the vehicle interior and tilt the flap forwards (see Fig. 1).
- Turn the rotary knobs fully to the left and then pull them forwards (see Fig. 2).
- Lift the bonnet at the front (see Fig. 3,1), then pull forwards, out of the rear guides (see Fig. 3, 2), and remove it.

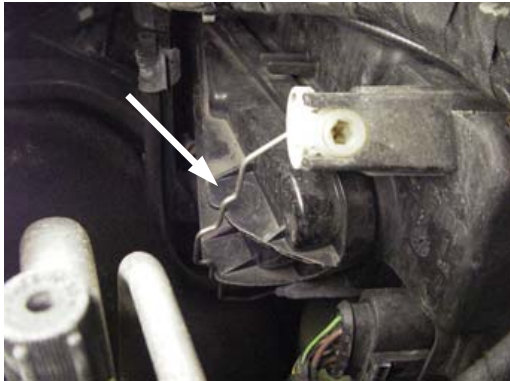
Fig. 4

- Loosen the cover-cap fastening clamp and remove it from the rear headlight-housing (see Fig. 4). A little patience is required, as space is somewhat tight here. Fastening the cap also requires care.
- Remove the spring-wire clamp and replace the bulb (see Fig. 5).

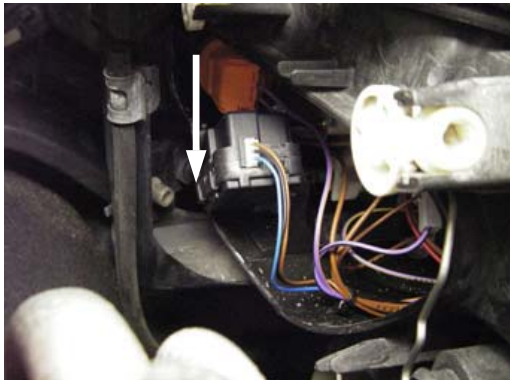
Fig. 6

- See low beam for previous steps.
- In order reach the bulb better, press the headlight-range adjustment motor downwards (see Fig. 6).
- Remove the spring-wire clamp and replace the bulb.

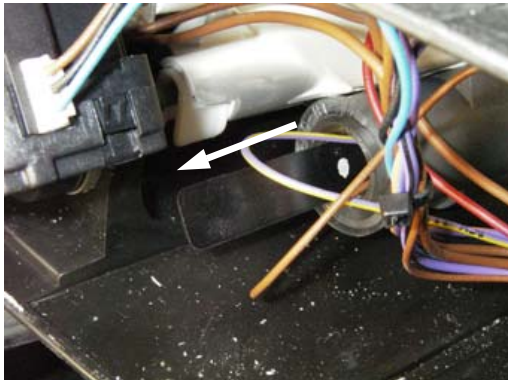
Fig. 7

- See low beam for previous steps.
- Pull the grip-type base out of the reflector and replace the bulb (see Fig. 7).

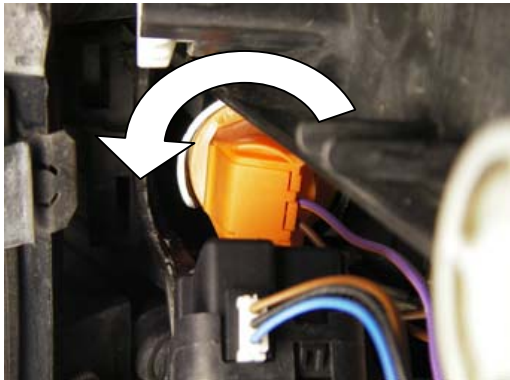
Fig. 8

- See low beam for previous steps.
- Turn the grip-type base fully to the left and remove it from the housing together with the bulb (see Fig. 8).
- Replace the bulb.
