## Citroën XM (Y4)

## Stop light not working/ stop light switch faulty

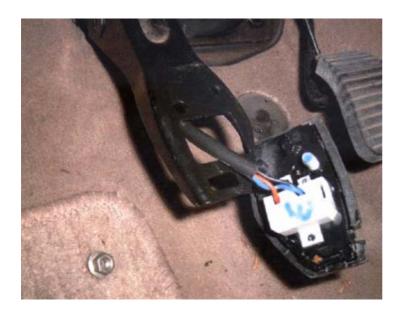
In the case of the above-mentioned vehicles without ABS, a faulty stop light switch can lead to failure of the stop lamps. The stop light switch (photo) is located in a plastic housing mounted on the brake pedal. The upper part (on the seat of the pedal rubber) is spring-loaded, and operates the switch via a small plastic pin. Since the switch switches the entire current of the stop lamps, the plastic pin can char due to excess load (in particular in the case of vehicles with a trailer). This shortens the pin, and the switching function is no longer guaranteed. In this case the switch must be renewed.
