Ford Mondeo

Model year: up to 11/1995

Engine: 1.8-litre turbo diesel

Engine cannot be switched off with the air conditioner switched on

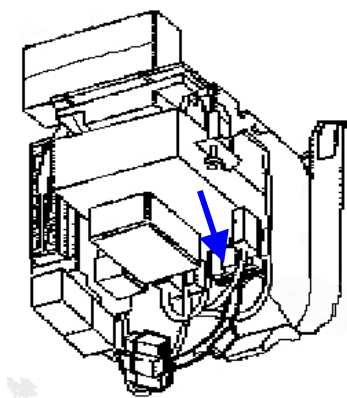
If the warmed-up engine of the above-mentioned vehicles cannot be switched off, the vehicle has possibly not been retrofitted with an additional cable. This cable, which is fitted with a diode and available through Ford dealers, is inserted between the 16-pin plug and the central electric box (see drawing). To do this proceed as follows:

- Remove the lower footwell cover (LHD) or pull out the glove box (RHD)
- Pull the 16-pin plug off the central electric box
- Insert the additional cable and reconnect the plug
- Refit the footwell cover or the glove box
- Carry out a functional test
