Land Rover

With diesel engine: Td5

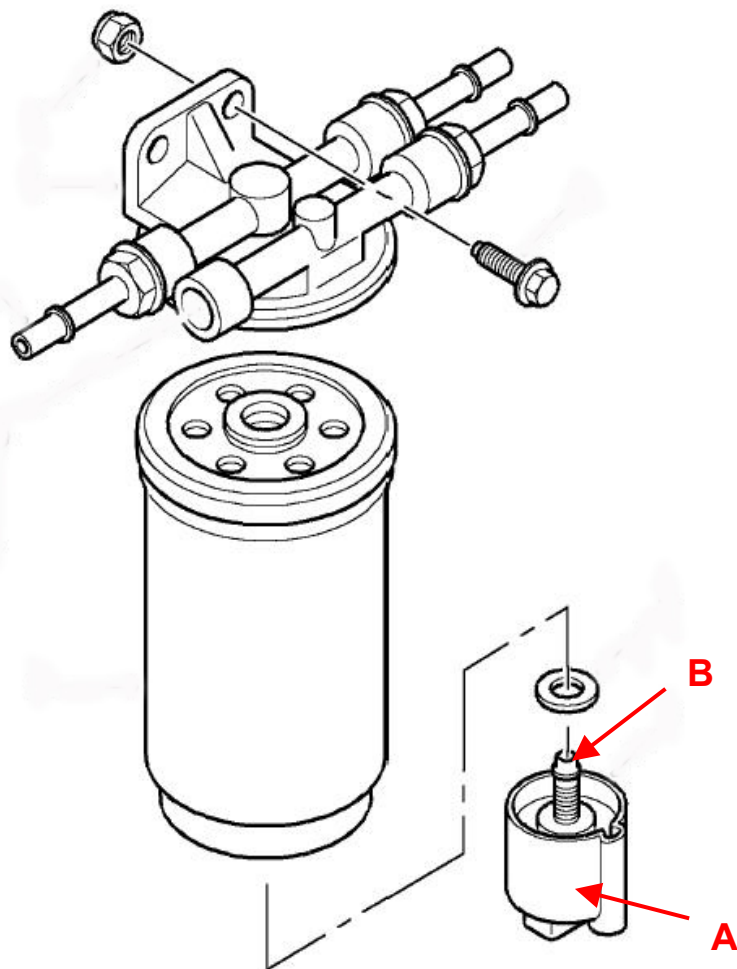
If the fuel filter warning light illuminates on the above-mentioned vehicles when driving, even though the filter has been drained or changed, this may also be caused by a dirty filter sensor. It is not therefore essential that the sensor is replaced immediately.

The sensor, which is fitted to the fuel filter, measures the resistance between two electrodes in the fuel. As a rule, when the ignition is switched on, the warning light goes out after approximately 2 seconds. If, however, there is too much water in the fuel, the change in the resistance value/current flow causes the warning light to be switched on permanently. In this case, proceed as follows:

- Check the electrical connection at the fuel filter sensor (the filter is located, in the case of the Defender for example, in the right-hand rear wheelhouse)
- Switch off the ignition and remove the connector from the sensor
- Place a collection container under the filter
- Remove the sensor (Drawing, item A), and catch the fuel
- Clean the sensor electrodes (Drawing, item. B) with a soft, clean cloth.
- Clean the seal and the sealing surfaces
- Fit the sensor
- Fit the connector
- If necessary, vent the fuel system

- Carry out a functional test and a leak test

If the fuel filter warning light still illuminates after this, the sensor should be replaced.
