Mercedes C-Class (W203) With comfort feature automatic air conditioning (Code 581b) Multi-function sensor/ compressor switch on often

Bulletin

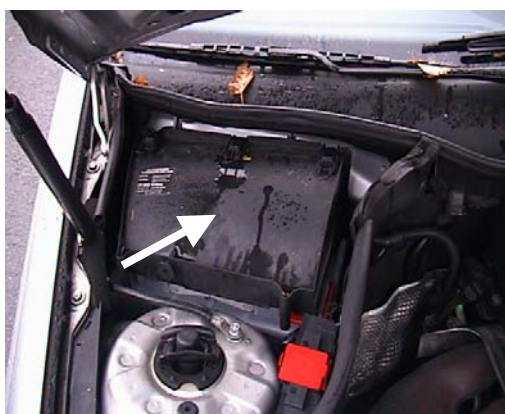
Fig. 1

In the case of the above-mentioned vehicles, an incorrectly calibrated multi-function sensor can lead to the compressor and the mirror heating switching on too often. This is the result of incorrect values which are transferred from the sensor to the CAN bus. The multi-function sensor monitors the carbon monoxide and nitrogen oxide content of the air before it is fed to the inside of the vehicle over an activated carbon filter. It activates the recirculating air mode if required. Before the sensor is replaced, the fault should be confirmed with the aid of a diagnosis unit. To replace the sensor, the housing (Fig. 1) of the interior filter must be removed first. Then both the dew point (humidity) sensor (Fig. 2, Pos. 1) and to the multi-function sensor (Fig. 2, Pos. 2) can be accessed.

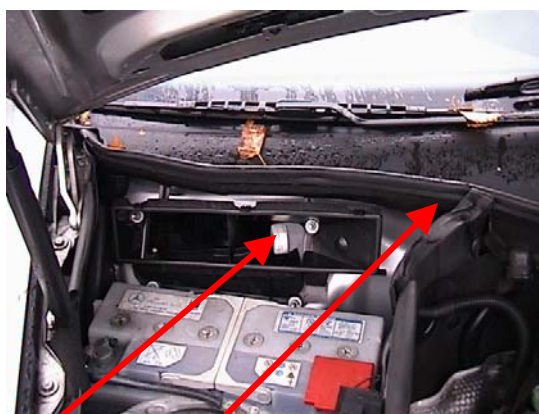
Fig. 2

Pos. 1 Pos. 2
