Opel Corsa B, Tigra, Astra F, Vectra B With engine: X14XE, X16XE, X16XEL

Noises / vibrations

Bulletin

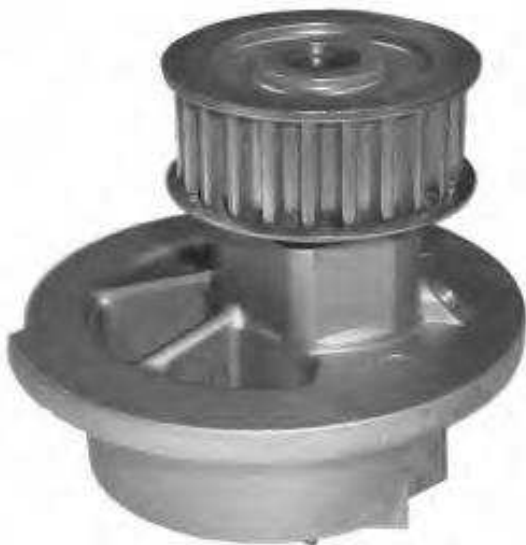
If, in the case of the above-mentioned vehicles, noises/vibrations occur in the area of the engine bay, the cause may be a defective coolant pump. Corrosion arises due to water ingress into the bearings of the coolant pump. This results in damage to the bearings, causing varying levels of noise and possibly also vibrations. In case of complaint, the coolant pump should be checked and, if necessary, replaced. From the following engine numbers onward, improved coolant pumps were used by the vehicle manufacturer as standard:

02 GD 1304 or 20010578
