Opel Vectra B, Omega B Engine: X25XE, X30XE

Excessive coolant temperature/ poor engine running

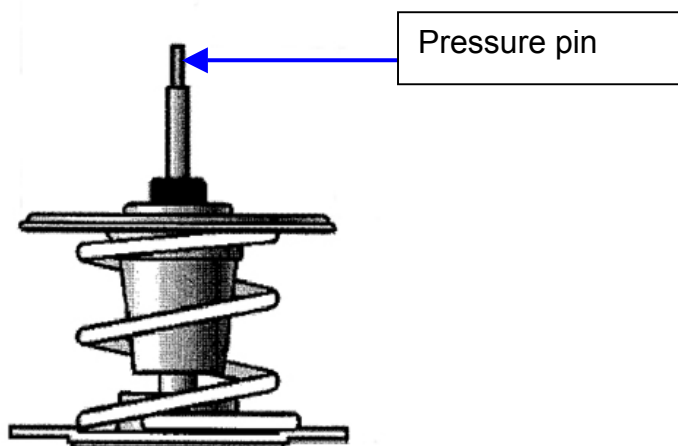
A faulty coolant thermostat can lead to excessive coolant temperature or poor engine running properties with the above-mentioned vehicles. The fault occurs in particular at increased engine load and speeds over 4000 rpm. A slipped pressure pin of the expansion element in the thermostat can lead to the thermostat not opening completely and the coolant temperature rising to above 120 °C. This then leads to the symptoms described above. To eliminate the problem the thermostat should be replaced.
