Renault Espace (JE)

Temporary failure of the air conditioning / heating fan

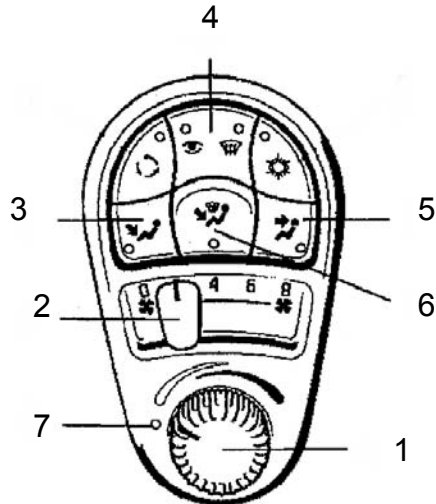
Carry out initialisation as follows, with the ignition switched off (see drawing):

- Set the temperature control (1) to "cold air" by turning it anti-clockwise (as far as it will go)
- Set the speed control (2) to "O" and press buttons 4+6 simultaneously, and, keeping them pressed, switch on the ignition
- As soon as warning lamp 7 flashes, release the buttons
- The setting has been successful if the warning lamps of buttons 5+7 are lit continually

- Disconnect the battery and remove if necessary
- Take the cover off the fuse box
- Remove the relay (234) with holder
- Remove the relay bracket and shorten the cable to a length of 150 mm
- Install the repair kit and connect to the vehicle cable strand
- Put back together in reverse order
- If necessary enter the radio code and, if LEDs 3+5+6 light up continually (see drawing), initialise the heating fan
