Renault Laguna (K74) 2.2 dci With Xenon light From model year 05.2005

Replacing the light source

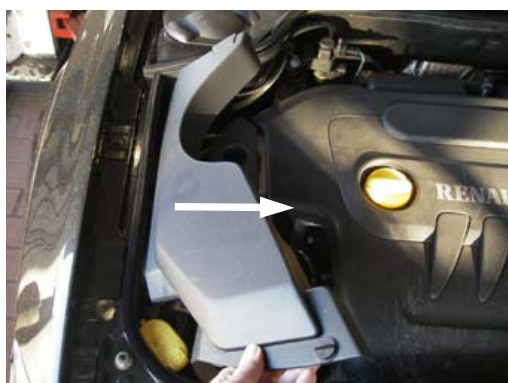
Fig. 1

- Turn the attachment clip 90° anti-clockwise and remove the cover. To do this, lift the cover slightly and pull it towards the inside of the engine compartment (see Fig. 1).
- Pull the oil container for the power steering upwards and out of the bracket and place it to one side (see Fig. 2).
- Pull the cover cap off the headlight housing.
- Turn the ignition module anti-clockwise as far as it will go and pull it off the Xenon light (see Fig. 3).
- Loosen the spring wire hoop and replace the bulb.

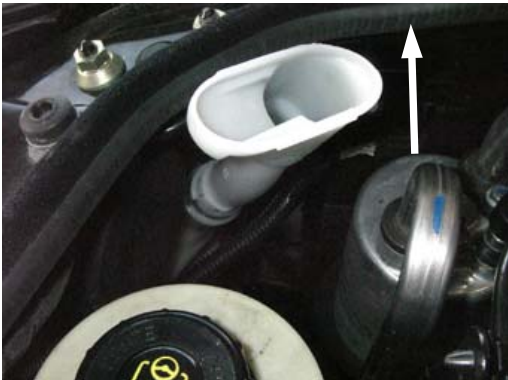
Fig. 4

- Pull the filling muffs of the windscreen washer system tank up and off, moving the muffs backwards and forwards slightly (see Fig. 4).
- Grip and turn the indicator light socket and remove it with the bulb (see Fig. 5).
