Renault

Scenic II (JM0/1)

Engine: 1.9 dCi

Replacing the light sources

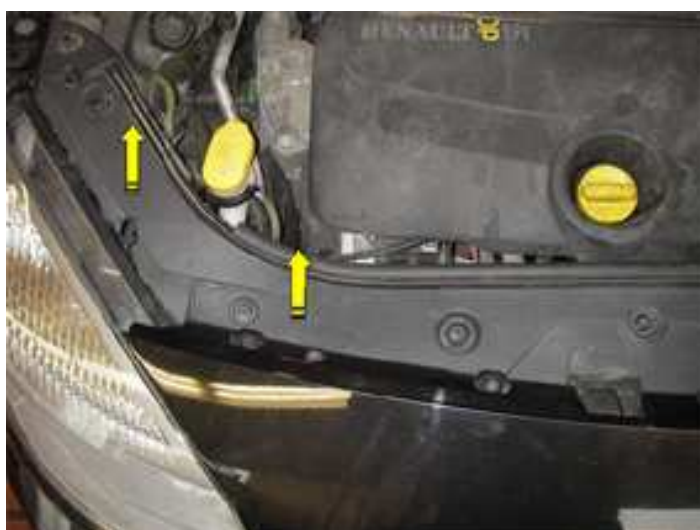
Fig. 1

- Switch off the ignition
- Open the bonnet
- Remove the cover above the headlight (Fig. 1)
- Remove the screws and plugs of the bumper, in the area of the lock carrier (Fig. 2)
- Remove the fastening screws (2x) of the headlight (Fig. 3)
- Remove the front screws of the lower engine cover
- Remove the screws of the mudguard panelling (right and left, 2x each) (Fig. 4)
- Pull the bumper forwards slightly
- Disconnect the electrical plug-type connectors for auxiliary lights that may be fitted
- Disconnect the hoses for the headlight cleaning system and close them off
- Remove the bumper
- Remove the lower fastening screws (2x) for the headlight, and remove the mounting bracket $\square A \square$ (Fig. 5)

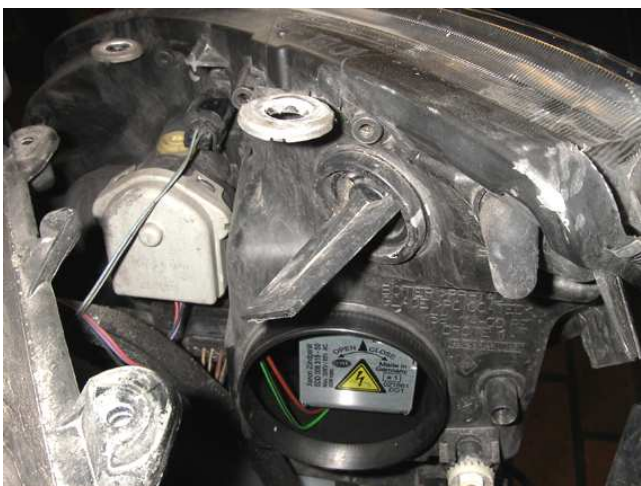
Fig. 6

- Pull the headlight forwards
- Replace the bulbs; if necessary, remove the covers and disconnect the electrical plug-connections in order to be able to remove the headlight completely (Fig. 6)
- Carry out a functional test
- Assemble the components in reverse order
- Check the headlight adjustment
