Citroen Relay - Auxiliary belt trouble

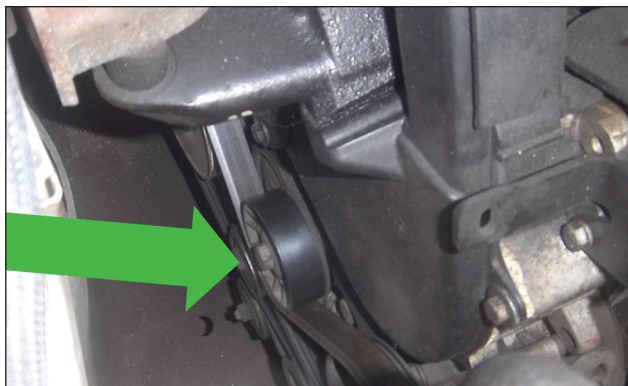
This was the point where he asked me if I could work out what was going on. Looking at the belt in position, I could see that the

A nice easy job, plenty of access to fit the new tensioner and belt

tensioner had worn and was kicking off to one side, preventing the belt from running true on the pulleys, and hence the reason why it had decided to jump off a couple of times.

The newly fitted belt was still in good condition, so a new tensioner was needed. Once fitted, the belt was replaced and when the engine was running, I could see it was now operating smoothly and should stay in place.
